# Environmental impact and remediation of uranium tailings and waste rock dumps at Mailuu Suu (Kyrgyzstan)<sup>1</sup>

**Abstract:** This paper describes the environmental situation in the former uranium mining and milling region of Mailuu Suu (Kyrgyzstan), the approach to environmental remediation of the waste facilities (tailings ponds and waste dumps) and the results achieved so far. It starts with an outline of the history of the environmental remediation project which has received international attention and is seen as pilot project for further remediation activities of former uranium mining and milling sites in the region. Apart from technical aspects, the paper draws conclusions with respect to the administrative environment, institutional capacity building and the local availability of resources needed to successfully implement a complex remediation project.

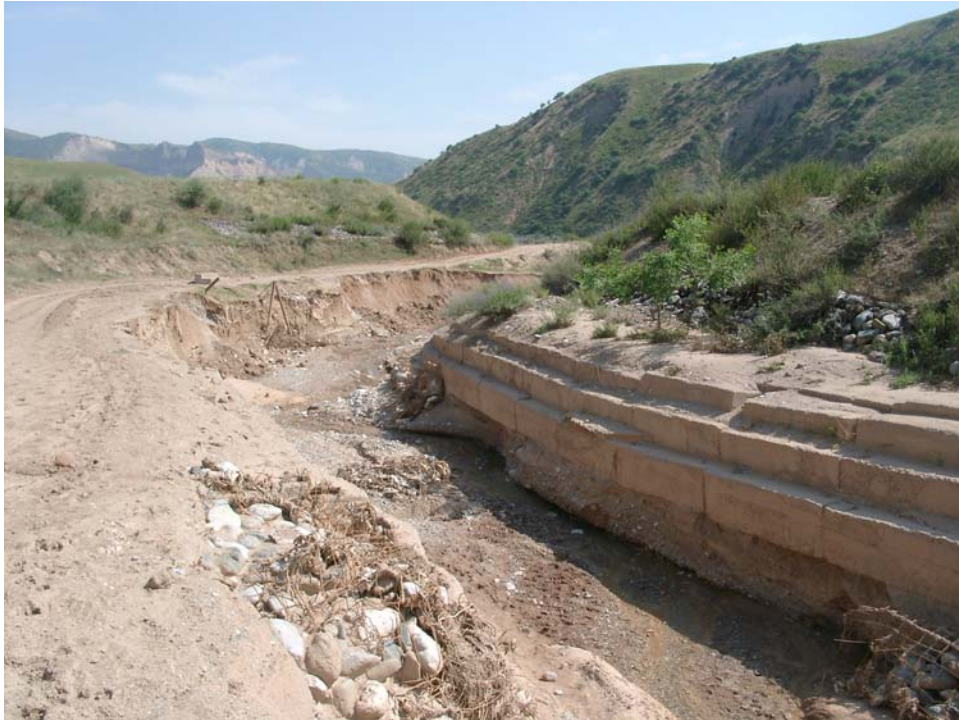
**FIGURE 1.** Fluvial erosion of the dam toe of tailings pond no. 2 and 13 in the valley of Aylampa Sai, a tributary of the Mailuu Suu river.

The most obvious and severe impact of waste facilities is due to the strong erosion of tailings and waste rock situated on the banks of the Mailuu Suu river and its tributaries. Erosion of wastes is caused both by rivers and creeks on whose banks the wastes have been deposited, and by the unhindered runoff of precipitation during strong rainfall events and snowmelt. Most striking examples are the waste dumps (WD) no. 1 and 2, and tailings ponds (TP) no. 2 and 13, see FIGURE 1.

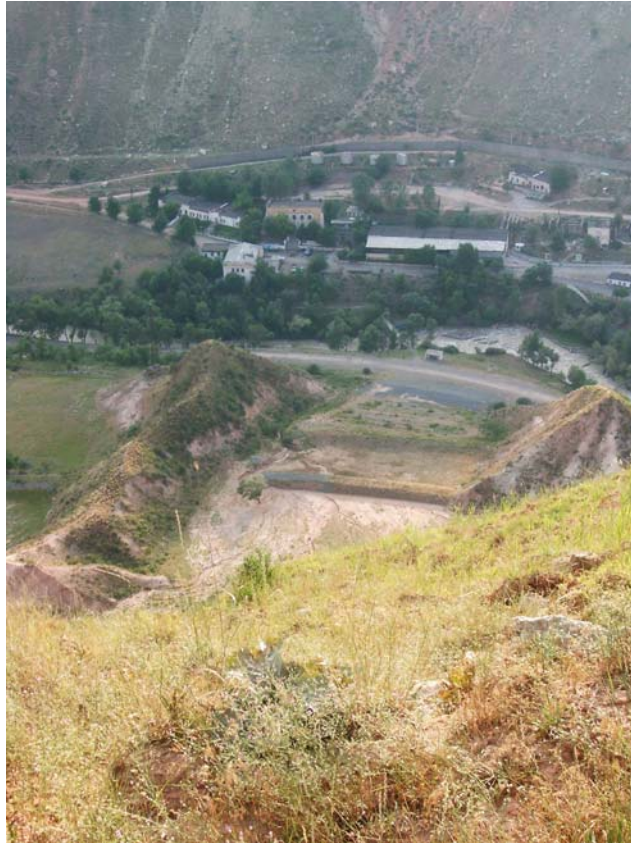
**FIGURE 2.** Tailings pond no. 3 seen from the cliff in its hinterland. Note the Mailuu Suu river behind the public road

Tailings pond (TP) 3 which is situated in the Mailuu Suu river valley, is unstable under seismic loads. TP 3 has been shown to be partially water saturated which is explained by springs beneath the tailings body. During the TACIS project [7], temporary stabilization measures in the dam area were carried out, and additional in-situ stabilization techniques have been discussed, but under long-term aspects relocation of the entire tailings pond is required.

Continuing erosion of loamy alluvial material from the hillslopes in the hinterland of TP 3 and its deposition on the tailings pond plateau leads to the build-up of a static load which further decreases the overall structural stability of the waste facility, see also FIGURE 2.
